# *K. R. Croasdale and Associates Ltd.*

August 27, 1985.

Re: Ice Investigation Around a Caisson Island in the  
Beaufort Sea (Contract DACA89-85-M-1684)

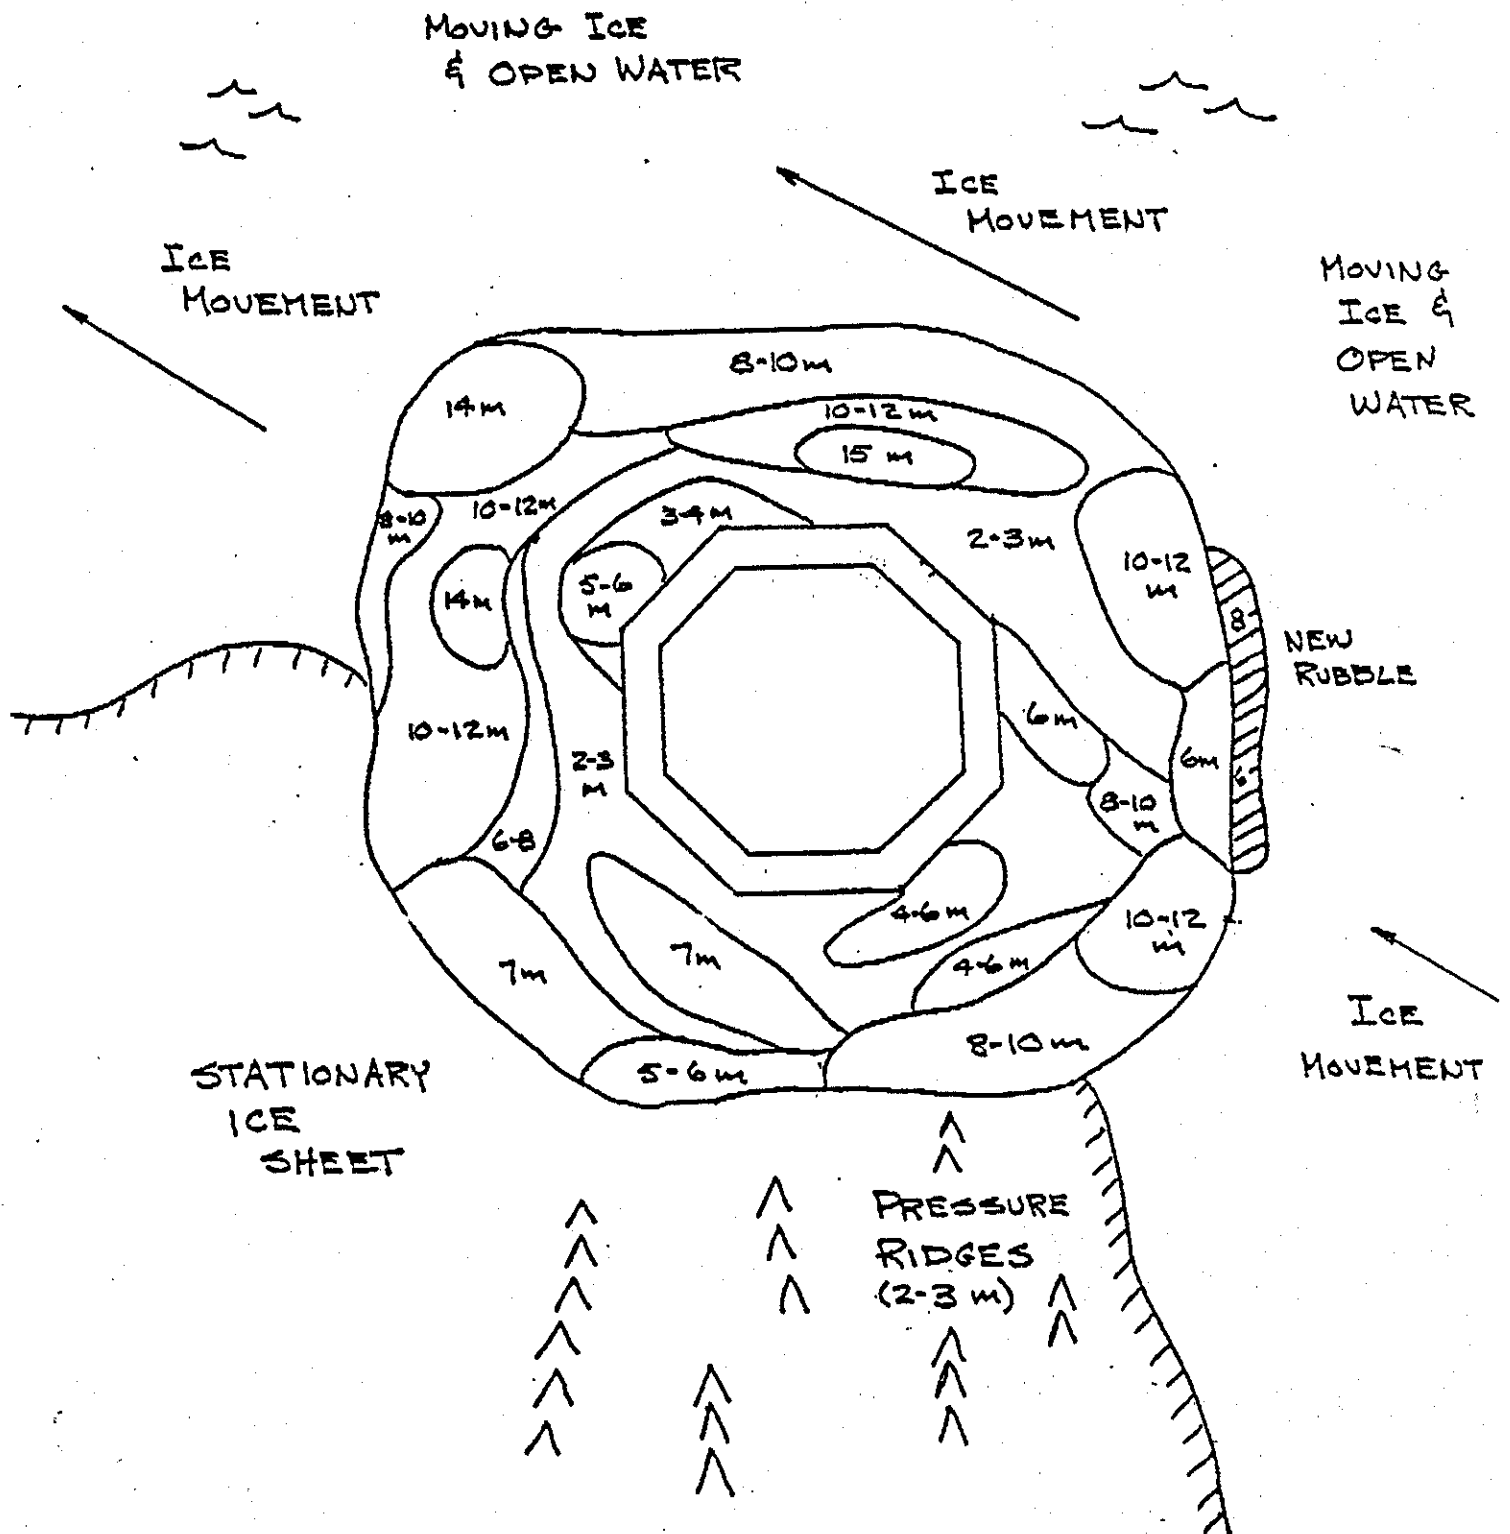
FIGURE 2

The combination of late funding; waiting to see if the ice would stabilize around the Molliqpak; and the necessity to wait for accommodation at the CRI, led to the field installation not commencing until February 21, 1985. By this time there was a fairly large grounded rubble field around the CRI (see Figures 2 and 3).

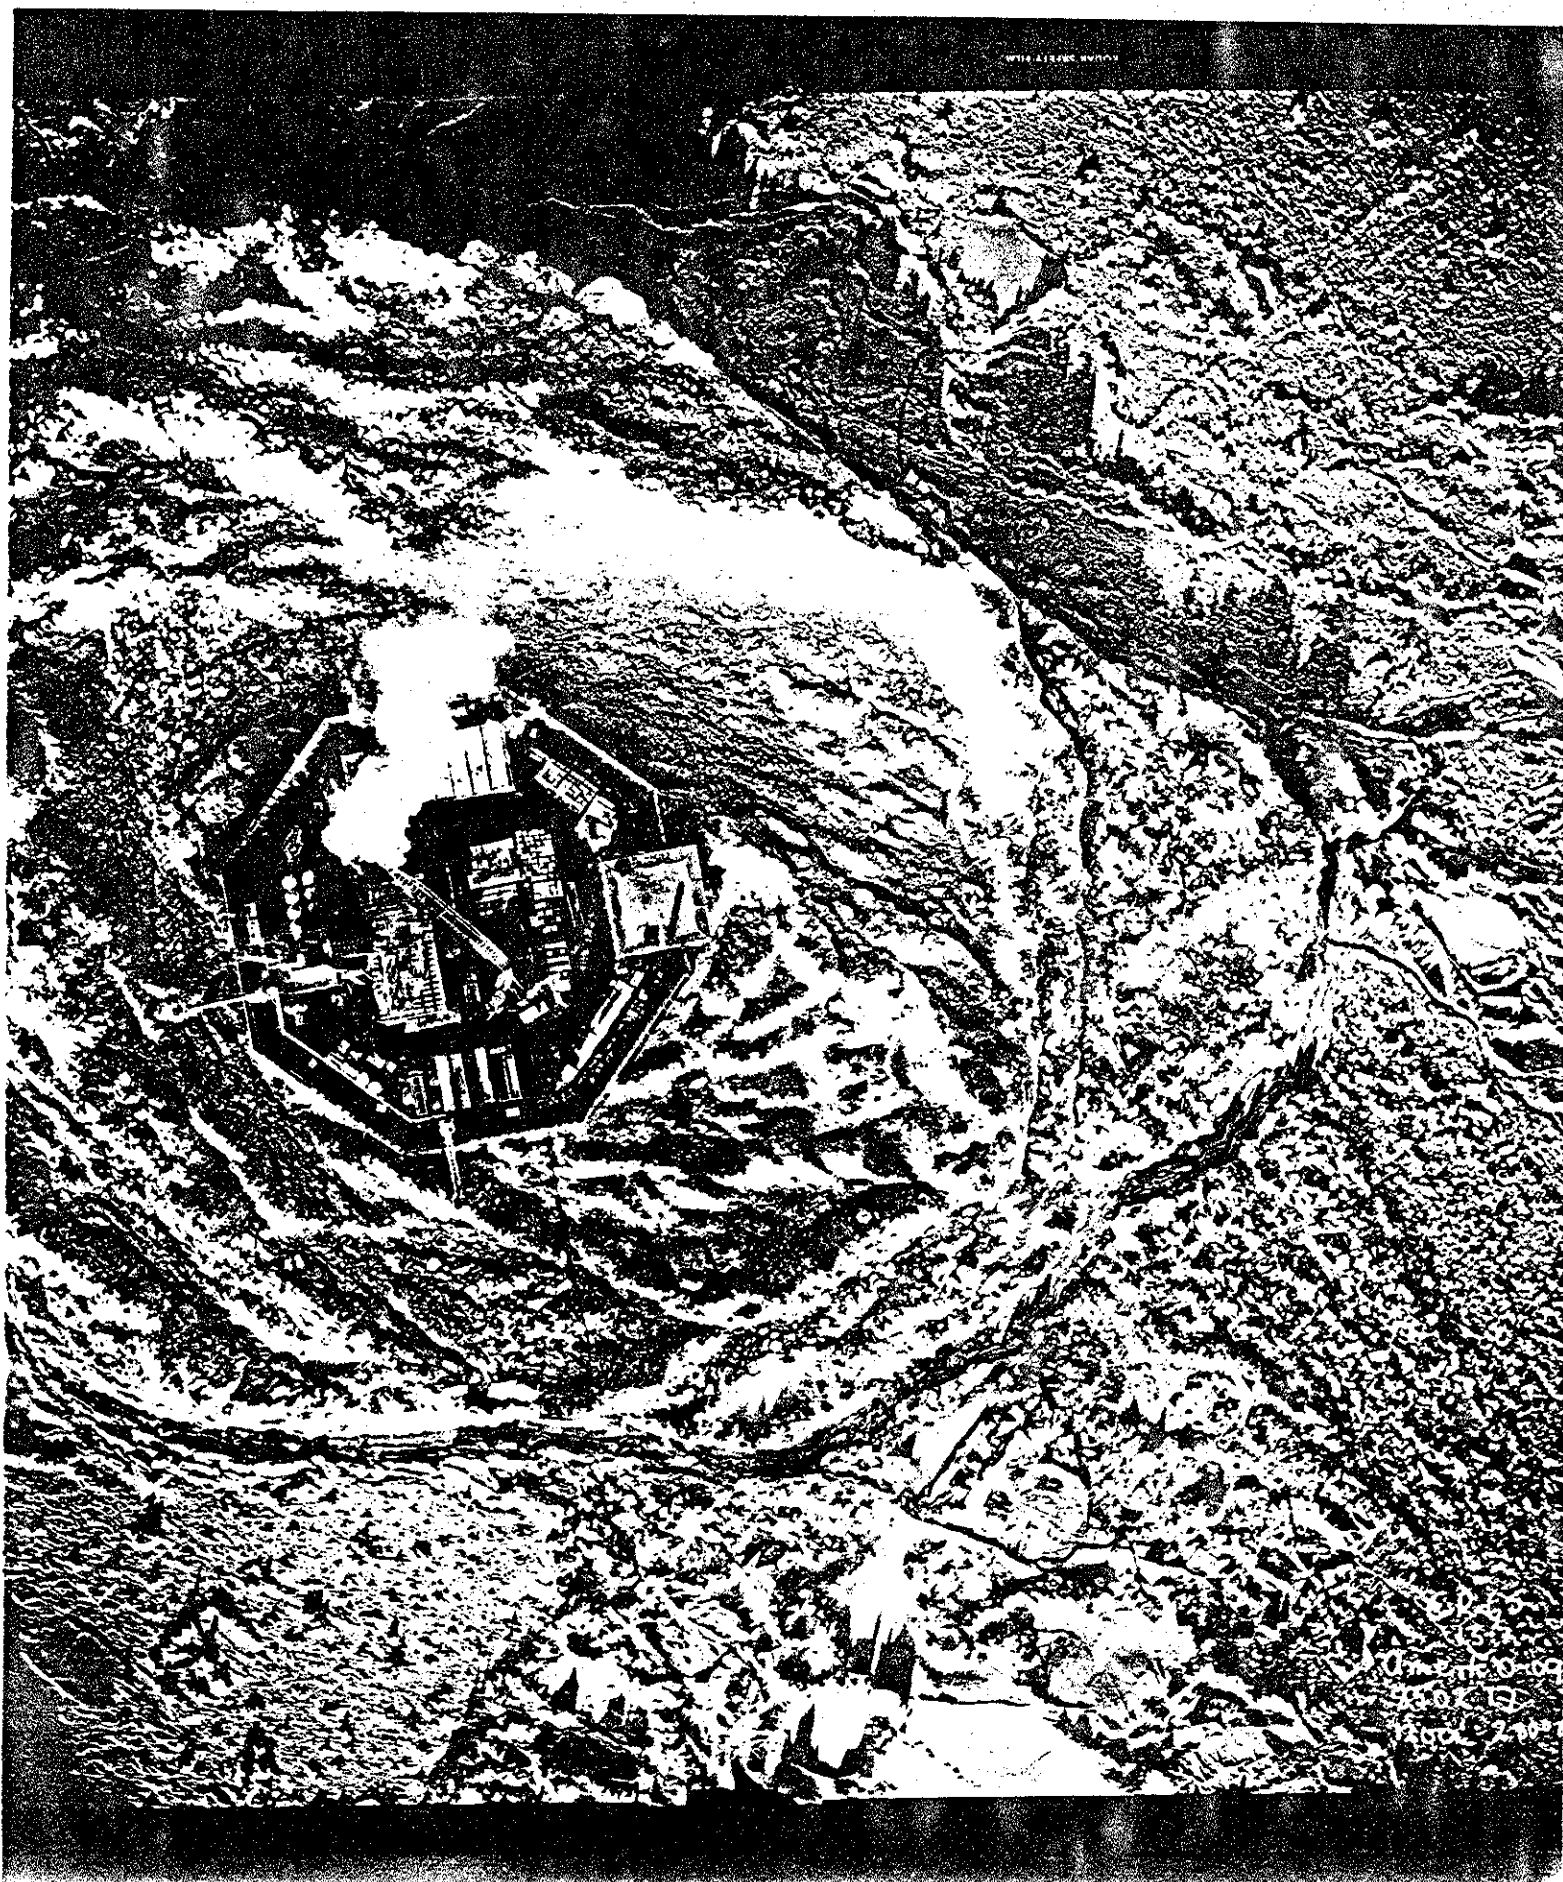
FIGURE 3

An immediate dilemma on arriving at the site was the question of where to deploy the sensors. The North and N.E. caissons are the most heavily instrumented (see Figure 4). Prior to arrival at the site, a review of rubble field features (see Figure 3) suggested a possible deployment of most of the sensors in a sector off the N.E. caisson where the rubble appeared to be low.

However, closer inspection of the rubble indicated virtually no flat spots off the N.E. caisson. Furthermore, the very high grounded rubble at the perimeter (10-15m) gave us concern that ice loads transmitted through to the caisson might be negligible. On the other hand, there were several flat spots in the rubble off the S.E. caisson. Furthermore, although the perimeter rubble was also high, it was expected that in the spring, loads from the south due to thermal expansion of the landfast ice might be significant. Therefore, the S.E. was the area chosen for the deployment of most of the sensors, see Figure 5.

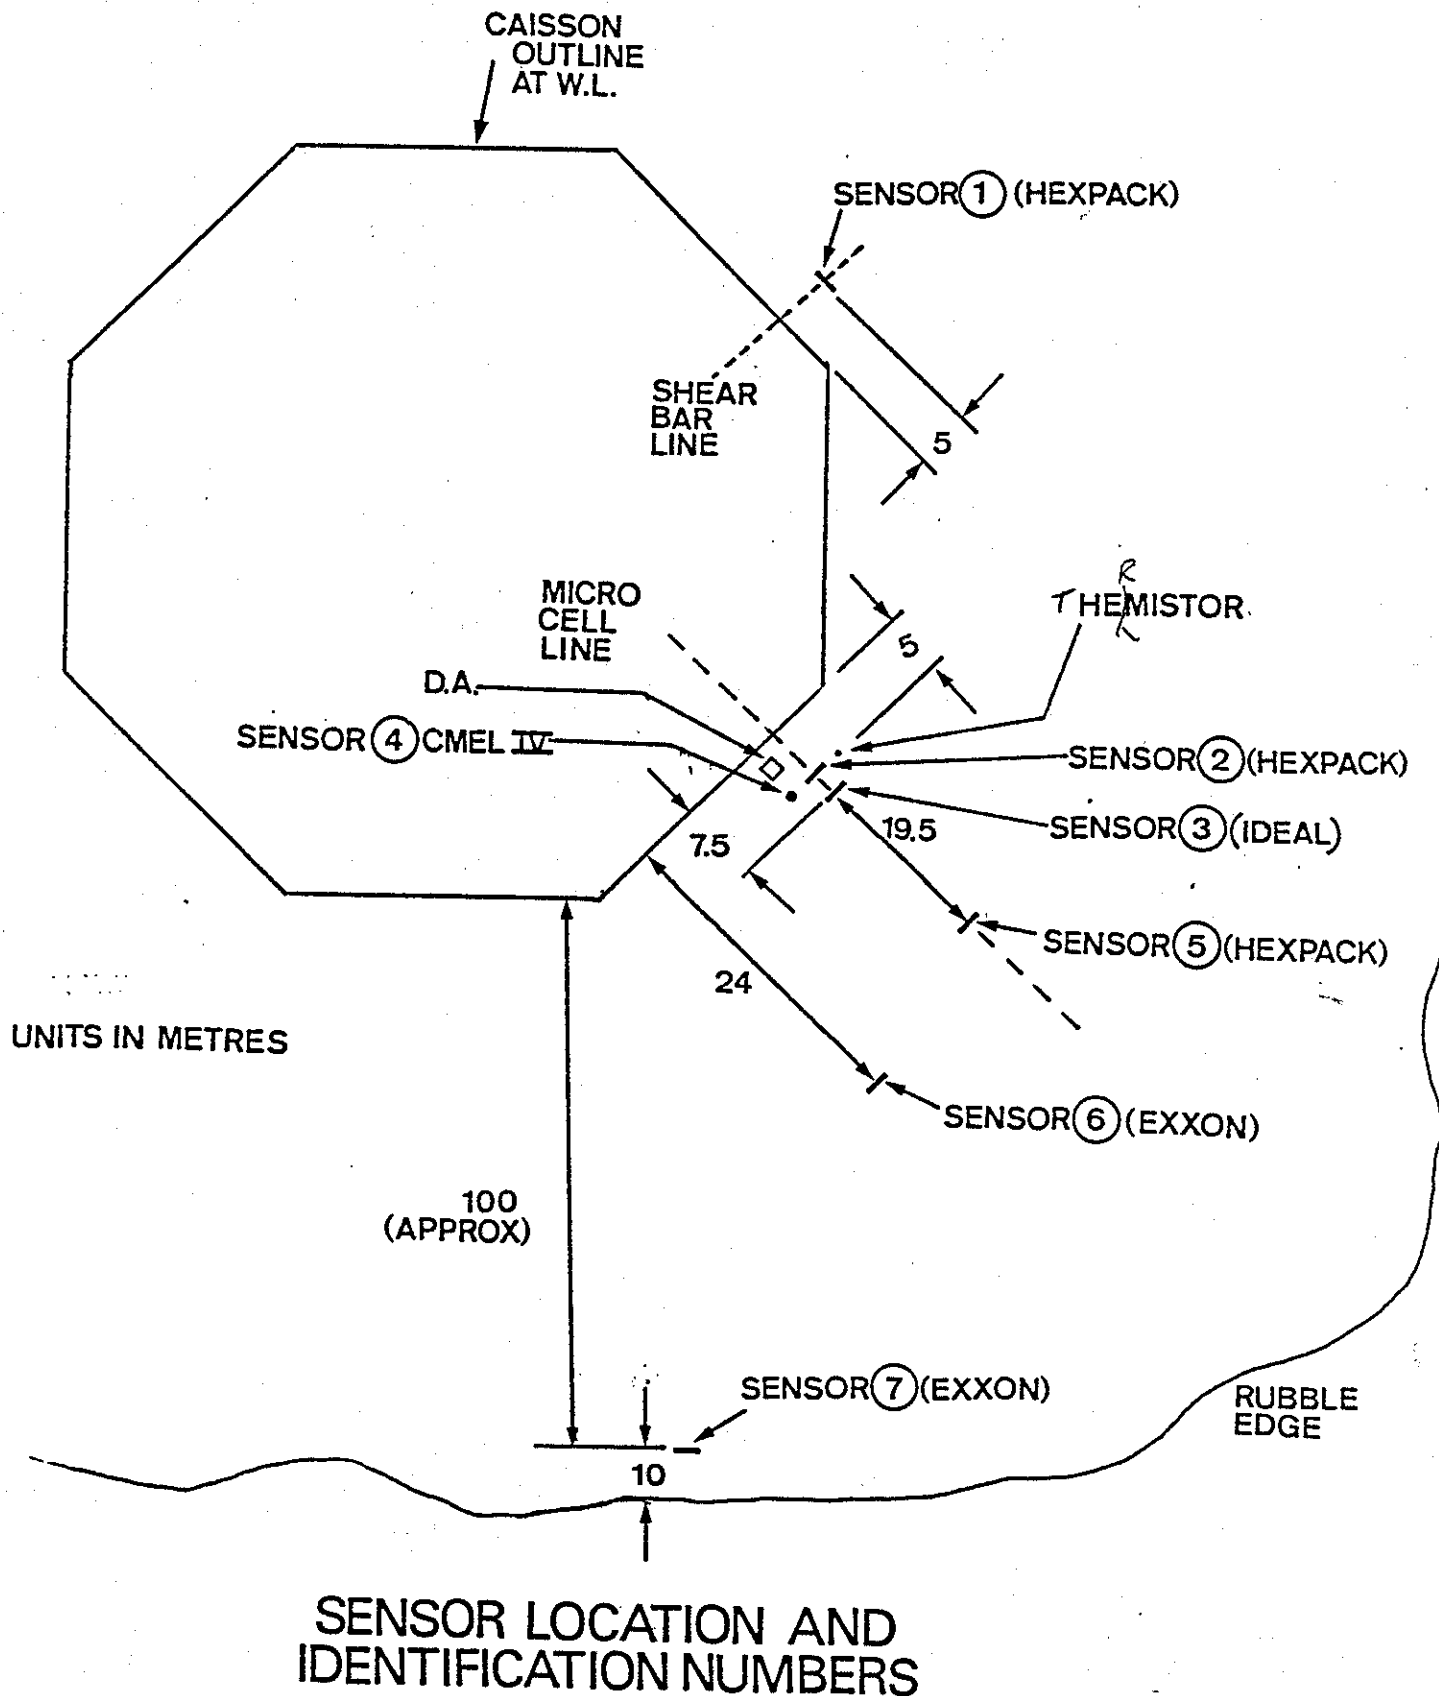
Figure 5

As already mentioned five sensors were deployed in the ice off the S.E. caisson (Figure 5). Three sensors of different types (Hexpack, Ideal and CMEL Mark IV) were installed close to the load instrumentation at the north end of the S.E. caisson. Another Hexpack was placed about 20m further out on the same radial line. For comparison an Exxon panel was placed a similar distance out from the caisson but further south.

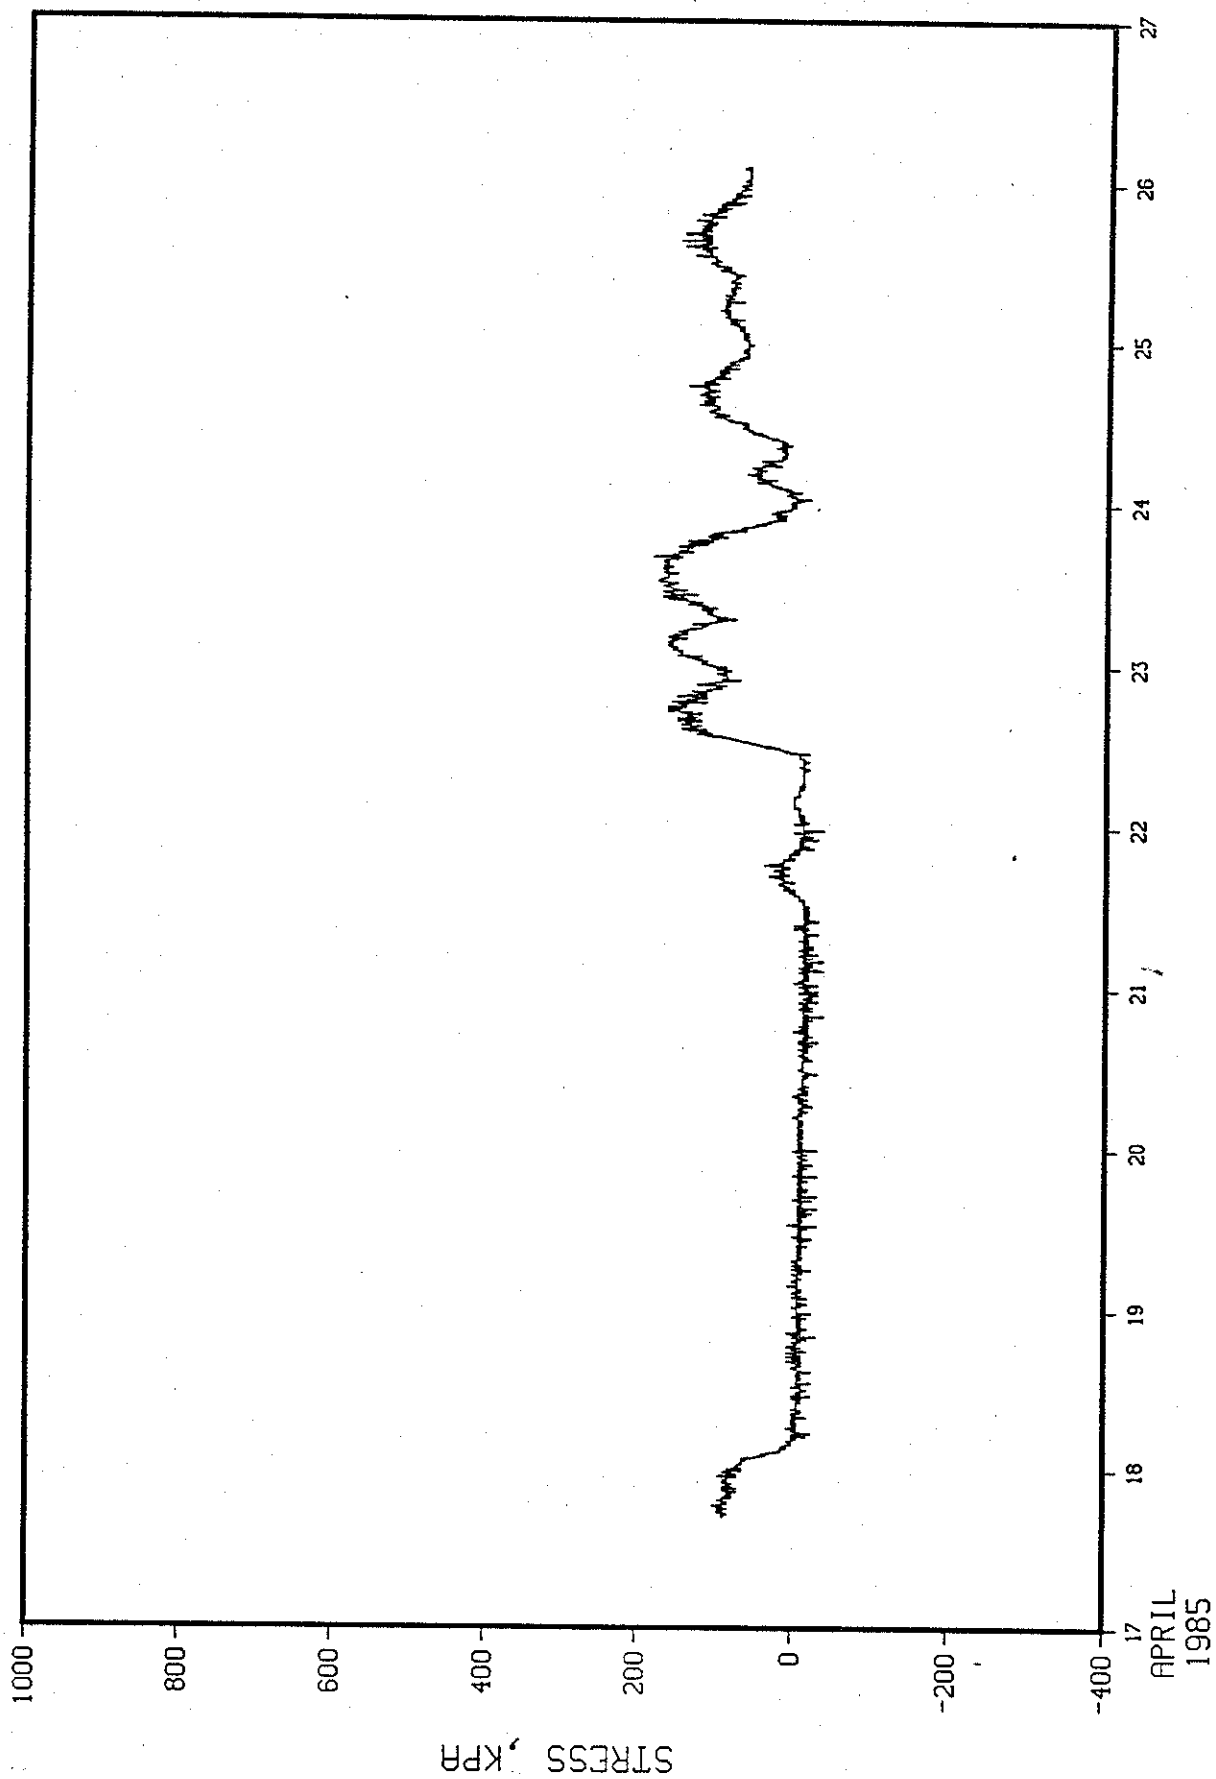
FIGURE 6

As expected, the sensor near to the rubble edge recorded the most ice pressure activity, although no event seems higher than about 200 kPa. Figure 6 shows some typical output. The results appear to be quite plausible. The Exxon sensor nearer to the caissons recorded very low to negligible ice pressure events. The Arctec Hexpacks show some activity at the various levels through the ice (see typically Figure 7). However these results need to be reviewed carefully before jumping to any conclusions, and this is what I am currently engaged in.
